Surface defects on collection coins of precious metals

The presence of various defects of different colours and sizes on precious collection coins is the cause not only of the rejection of defective coins but also of an increase in the production costs. In this work, the surface defects on the Austrian collection coins have been investigated by using the techniques of XPS, AES and SEM/EDS.

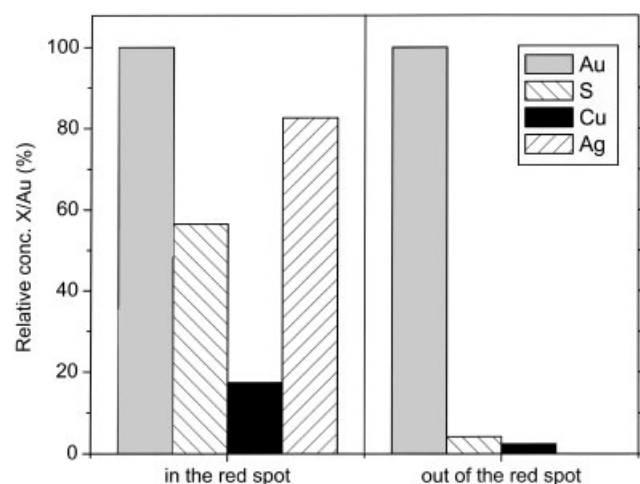
The surfaces of the studied gold coins (ancient and modern) exhibited various spots of different sizes and colours. The colour of these stains varied from light red to black. A thorough SEM/EDS analysis³ exposed the morphology of these defects and the presence of silver in all the spots. Typical results of XPS measurements of the red spots are shown in Fig. 1. It is clear that these spots contain Ag, S and a lower amount of Cu. The SEM image and SAM chemical map (Peak-Background) of Ag of the same stain are presented in

Figure 1. XPS results on the 200 Austrian schillings coin (Au 999.9).

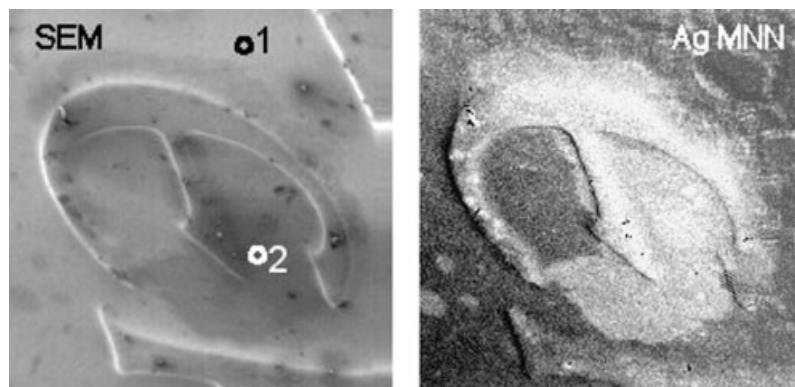
Figure 2. SEM image and SAM chemical map (Ag MNN) of the red stain on the 200 Austrian schillings coin (Au 999.9). The image size is $1.8 \times 1.8 \text{ mm}^2$.

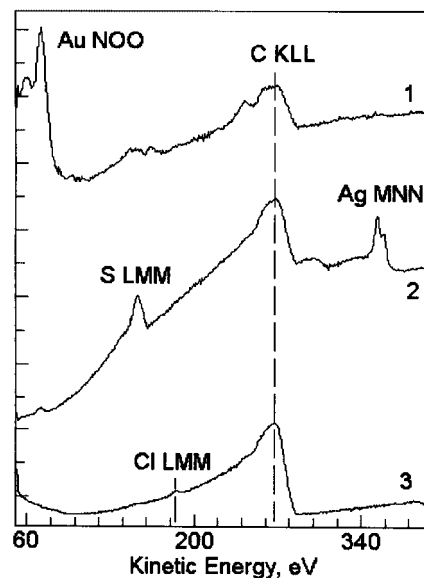
Fig. 2. Multipoint AES analysis (Fig. 3) of the clean surface (1), red stain (2) and a smaller black spot (3, out of the area shown in Fig. 2) reveals the nature of these defects. The reddish stains contain Ag, S and Cu (peak not shown in Fig. 3).

Figure 3. Multipoint Auger spectra of the 200 Austrian schillings coin (Au 999.9). Points 1 (clean surface) and 2 (in the red stain) are indicated in Fig. 2; point 3 (black spot) is out of the area shown in Fig. 2.

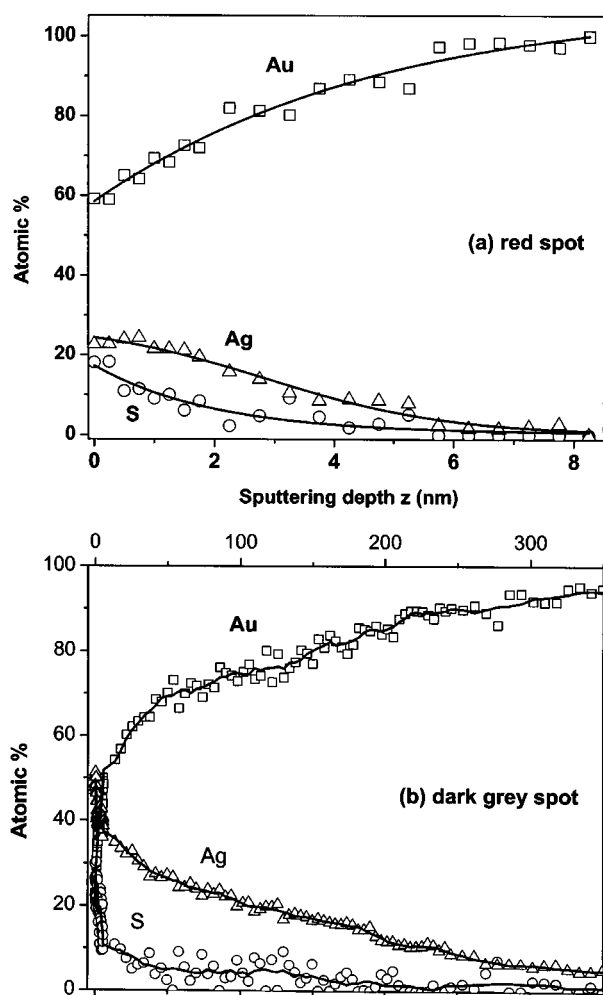
Figure 4. XPS depth profiles of the 1000 Austrian schillings coin (Au 999.9): (a) area of the red stain; and (b) area of the dark grey stain.

The XPS and AES analyses of the dark stains gave results very similar to those of the reddish stains. Only the XPS depth profiling (Fig. 4) revealed the compositional differences of these stains. The total thickness of the red stains is about 5–6 nm and they consist of two sub-layers. In the first 2–3 nm, Ag_2S is dominant, while deeper in these defects only metallic Ag is detected. In the dark grey stains, the concentration of S rapidly decreases to zero in the first 5 nm, while the second sub-layer of metallic Ag continues in-depth for about 300 nm. Evidently the difference of colour is not due to the difference of chemical composition or of structure, but to the difference of thickness of the inner silver layer.

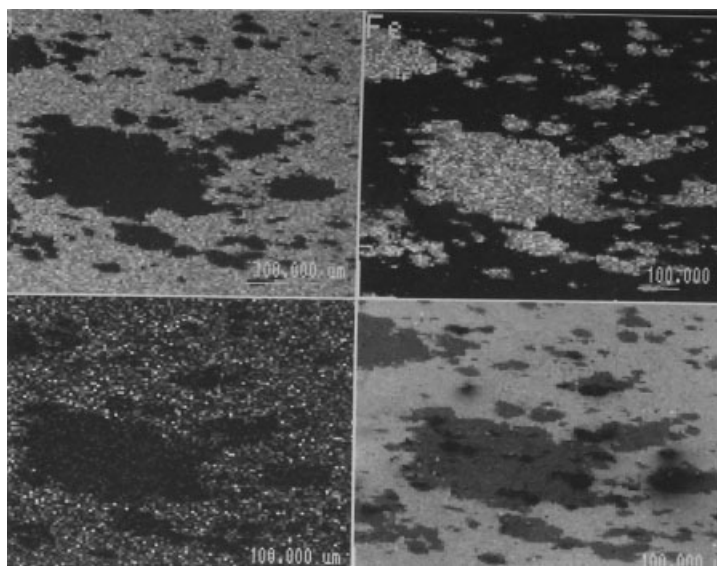
The nature and origin of the dark blackish spots on silver coins and blanks is quite different. Two different types of these defects were disclosed. Figure 5 displays the SEM image and EDS chemical maps of one of them on the surface of a Ag 925 blank sample. The morphology of these defects indicates that they consist of foreign particles, rich in Fe, embedded in the silver matrix. The presence of Fe was confirmed also by AES and XPS measurements of the dark spots. The dominant chemical state of iron is Fe^{3+} (two Fe 2p components at *BE* of about 711 and 713 eV), that remains stable even after 30 min of ion sputtering. Therefore, these spots consist of iron compounds produced by thermal treatment of steel, whereby their origin can be explained by focusing attention on the furnace used for the annealing of silver strips. Its lining is made of stainless steel which oxidizes forming a brittle scale. If some particles of this scale fall on the surface of the strips, they can be embedded onto the silver alloy by the successive rolling.

Figure 5. SEM image (bottom right) and EDS chemical maps of a Ag 925 blank sample with dark spots: Ag (top left), Fe (top right), Cu (bottom left).

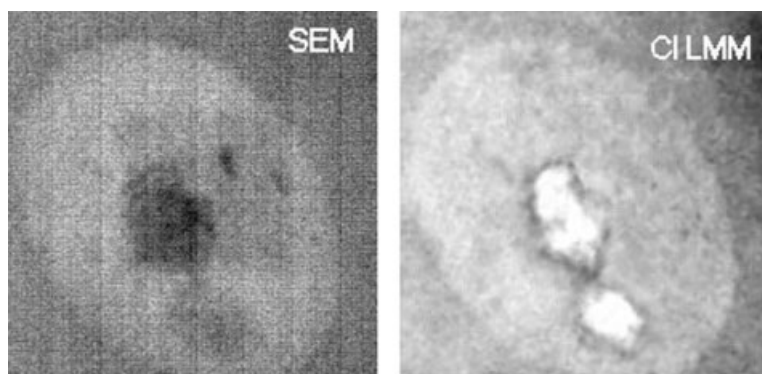
Another kind of defect (see Fig. 6) consists of small round white stains, about 1 mm in diameter, with a dark spot in the centre. Small particles of 2–20 μm are distributed inside these

Figure 6. SEM image and SAM chemical map (Cl LMM) of the white stain on a coin of Ag 999. The image size is $0.8 \times 0.8 \text{ mm}^2$.

stains. EDS analysis disclosed that: (i) the ratio of chlorine and silver is constant ($\text{Cl}/\text{Ag} \sim 0.1$) over all of the area of the dark spot; and (ii) in the small particles the amount of Cl is higher.

The SAM chemical maps (Fig. 6) and XPS data, obtained after cleaning by ion sputtering, confirmed the presence of chlorides. This fact is quite important because silver, and even more so its alloys, in contact with an aerated solution containing Cl^- ions, is oxidized resulting in the formation of a surface film of AgCl. Other tests, made to reproduce these stains, confirmed that one of the commercial products used in the coins' production is contaminated with chlorides and these defects are actually composed of AgCl.
